| Audit Date: May 15, 2025 | Registration numbers: F_IAR_212366 |
| Audit Team: Scarlett Qin | Facility Name: Huizhou Tongfu Zhihui Animation Co., Ltd |

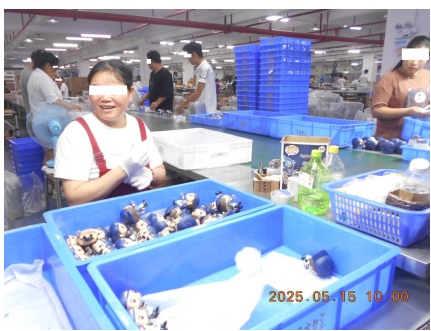
| <NC: Some employees who using cleaner did not wear activated carbon mask or plastic glove though facility had provided to employees.<br>> | <NC: Around 5% chemical in facility had no secondary container.> | Nil |
